## *Message/Alarm “Clean C-HEAD” appears*

## *Procedure for cleaning:*

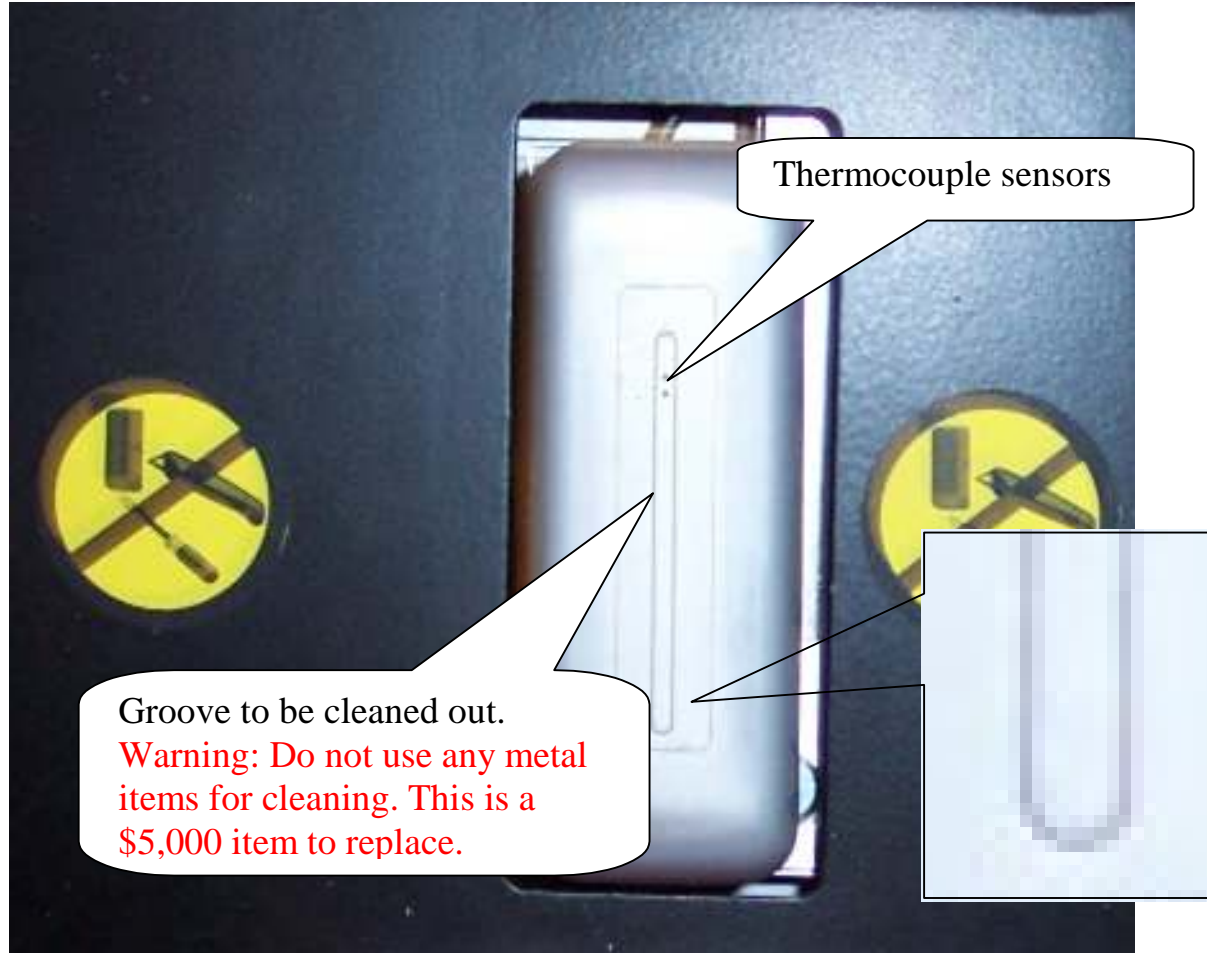
A build up of resin and dirt will cause a bridging across the gap on the capacitive sensor reducing the measurement reading. It is recommended to clean the sensor on a 4 week cycle depending on polymers used and content of reclaim. It only takes five minutes and can be done with the line running if desired.

If the profile measurement is running, stop the function by either double touching the PROFILE button on the machine control screen or turning off the power on the control box PC9 that controls the profile scanner. Stop the radial adjustment arm where it is best reachable for cleaning.

- With a clean cotton rag and an alcohol based cleaning solution wipe the surface of the capacitive sensor until no visible dirt or polymer is showing.
- With a non-metal tool, (i.e. toothpick, sharpened piece of wood, toothbrush, pointed plastic item) clean out the groove that goes around the center of the sensor. This area will collect polymer and dirt and over time will short out the two capacitive plates.
- Restart the measurement sensor, remember to turn on the scanner if the switch was turned off on the PC9 box.
